APPENDIX N.
VISUAL CONTRAST RATING WORKSHEET

1. Project Name Alton Coal EIS		4. Location UTM - 12 S 0369399 4144477	5. Location Sketch See attached photo
2. Key Observation Point #1 Town of Alton, east side, looking south

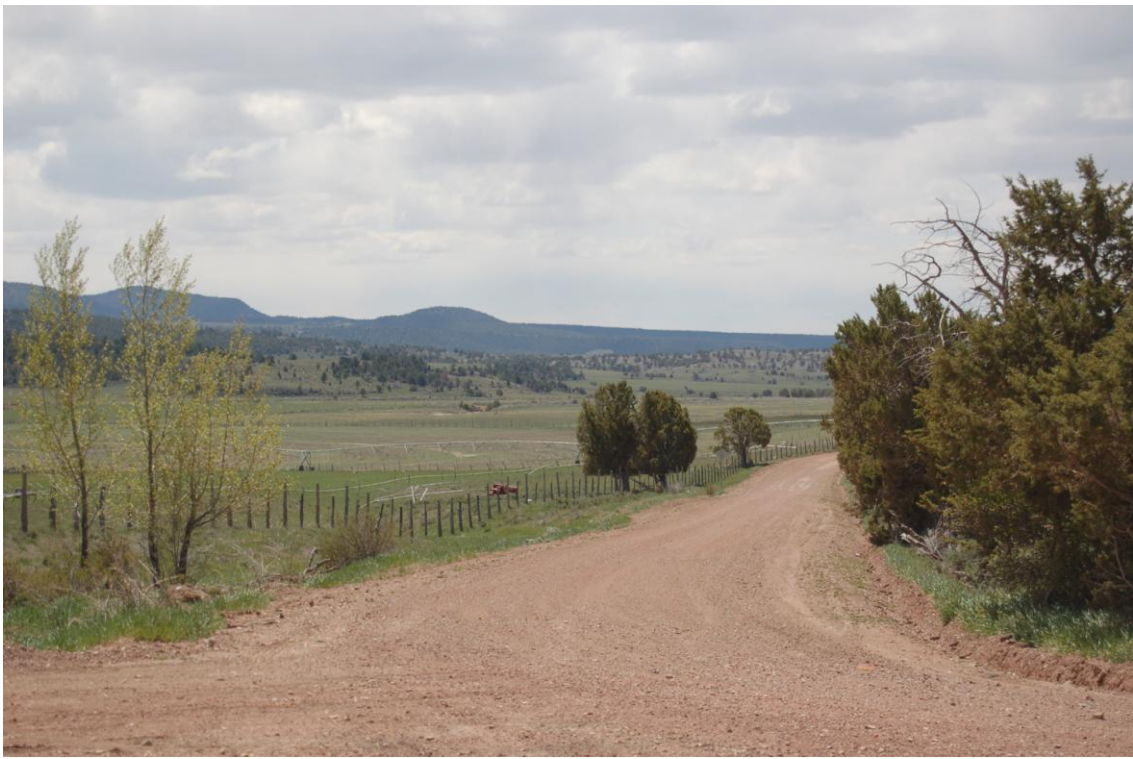
3. VRM Class IV			
SECTION B. CHARACTERISTIC LANDSCAPE DESCRIPTION			
1. LAND/WATER		2. VEGETATION	3. STRUCTURES
FORM	Large, open, natural landscape. Gently rolling hills throughout north south trending valley. Somewhat jagged low rising mountain ranges in the BG.	Distinct stands of rounded juniper interspersed with taller pinyon and low rounded sagebrush and grasses in MG and BG. Tall conical fir trees on mountains to the west.	Bucolic setting. Rectangular geometric structures in town of Alton. Low, flat agricultural fields in FG.
LINE	Hills throughout valley form gentle undulating, sweeping horizontal lines.	Long sweeping line of trees following lines of hills. Diffuse edge of stands of juniper along hills and diagonal to surrounding mountains.	Long angular lines of juniper post barbed wire fences. Geometrical lines of agricultural fields in FG.
COLOR	Area is currently covered in vegetation. Some dull grays and tans visible on mountains in the BG.	Multiple shades of green – dull light gray/greens of shrubs and grasses to darker greens of junipers.	Reflective silver irrigation lines. Buildings and homes are metal, white, tan and earth tones. Vibrant bright green fields in FG.

TEX- TURE	Mountains in BG medium to coarse.	Dense stands of juniper and sage. Medium stands of fir.	Structures are smooth in BG, rougher in the FG. Smooth fields in FG.
SECTION C. PROPOSED ACTIVITY DESCRIPTION

1. LAND/WATER		2. VEGETATION	3. STRUCTURES
FORM	Most of disturbance would be in MG. Large horizontal edge of high wall and pit disturbance (removal of up to 300 feet of overburden, up to 600 foot high wall) interspersed with rolling hills. Temporary tall, conical stockpiles of topsoil. Temporary tall, conical stockpiles of coal. Underground mining is proposed for FG.	Patchy stands of vegetation interspersed with pit and road disturbance.	Portable and fixed location 30 foot tall vertical light towers. Geometric Diesel power generators. Flat, rectangular entrance sign to tract would be visible from this point.
LINE	Multiple sharp, geometric lines	Sharp butt edge between vegetation and pit disturbance.	Simple sharp vertical lines, geometric, rectangular generators.
COLOR	Grays, tans, and reddish browns of exposed soils and rocks of pit and new mine roads. Darker grays, blacks of stockpiled coal.	None	Reflective metal light towers, dull metallic generators. Reddish tan service roads.

Looking Southwest down KFO Route 116.

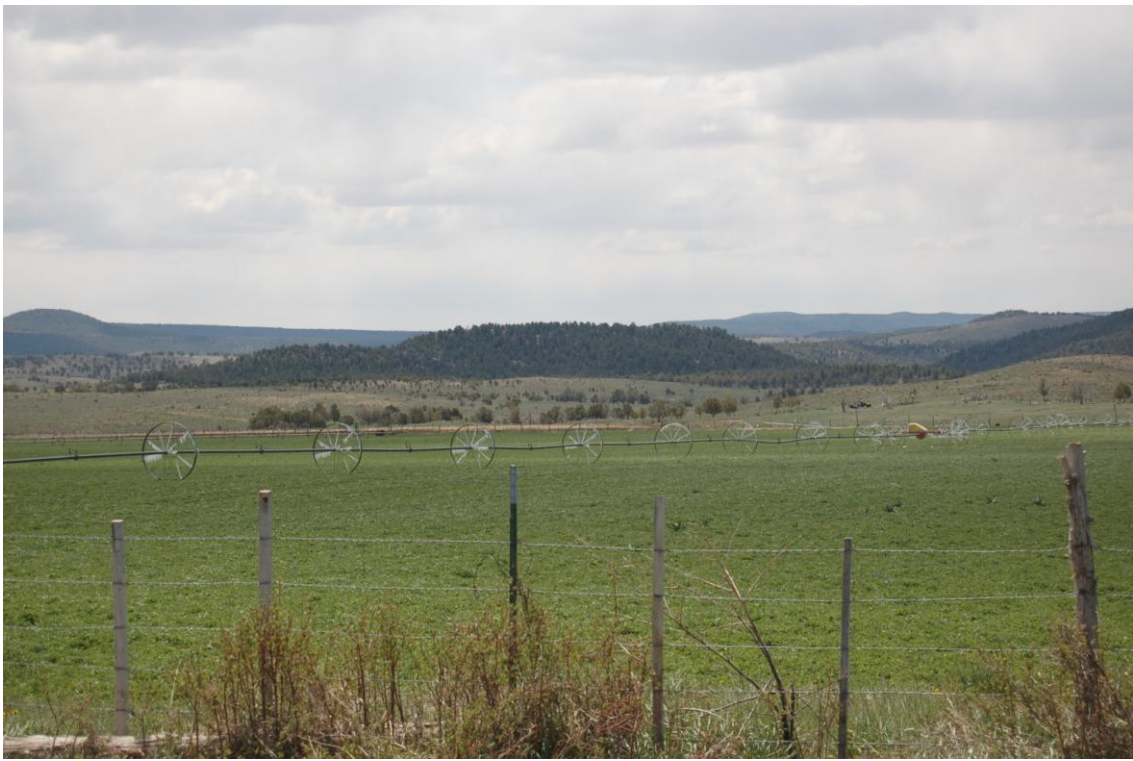
1. Project Name Alton Coal EIS		4. Location UTM - 12 S 0368817 4144280	5. Location Sketch See attached photo	
2. Key Observation Point #2 Town of Alton, south end of main street, looking south

3. VRM Class IV				
SECTION B. CHARACTERISTIC LANDSCAPE DESCRIPTION				
1. LAND/WATER		2. VEGETATION		3. STRUCTURES
FORM	Large, open, natural landscape. Gently rolling hills throughout north south trending valley. Somewhat jagged low rising mountain ranges in MG to the west.	Distinct stands of rounded juniper interspersed with taller pinyon and low rounded sagebrush and grasses in MG and BG. Tall conical fir trees on mountains to the west.		Bucolic setting. Rectangular geometric structures in town of Alton. Low, flat agricultural fields in FG.
LINE	Hills throughout valley form gentle undulating, sweeping horizontal lines.	Long sweeping line of trees following lines of hills. Diffuse edge of stands of juniper along hills and diagonal to surrounding mountains.		Angular lines of juniper post barbed wire fences. Lines of irrigation set-up on a diagonal with large round wheels. Geometrical lines of agricultural fields in FG. Tall vertical trees associated with homes in town.

COLOR	Area is currently covered in vegetation. Some dull grays and tans visible on mountains in the BG.	Multiple shades of green – dull light gray/greens of shrubs and grasses to darker greens of junipers.		Reflective silver irrigation lines. Buildings and homes are metal, white, tan and earth tones. Vibrant bright green fields in FG.
TEX- TURE	Mountains in BG medium to coarse.	Dense stands of juniper and sage. Medium stands of fir.		Structures are smooth in BG, rougher in the FG. Smooth fields in FG.
SECTION C. PROPOSED ACTIVITY DESCRIPTION

1. LAND/WATER		2. VEGETATION		3. STRUCTURES
FORM	Most of disturbance would be in MG. Large horizontal edge of high wall and pit disturbance (removal of up to 300 feet of overburden, up to 600 foot high wall) interspersed with rolling hills. Temporary tall, conical stockpiles of topsoil. Temporary tall, conical stockpiles of coal. Underground mining is proposed for FG.	Patchy stands of vegetation interspersed with pit and road disturbance.		Portable and fixed location 30 foot tall vertical light towers. Geometric Diesel power generators.
LINE	Multiple sharp, geometric lines	Sharp butt edge between vegetation and pit disturbance.		Simple sharp vertical lines, geometric, rectangular generators.
COLOR	Grays, tans, and reddish browns of exposed soils and rocks of pit and new mine roads. Darker grays, blacks of stockpiled coal.	None		Reflective metal light towers, dull metallic generators. Reddish tan service roads.

Looking south from community of Alton.

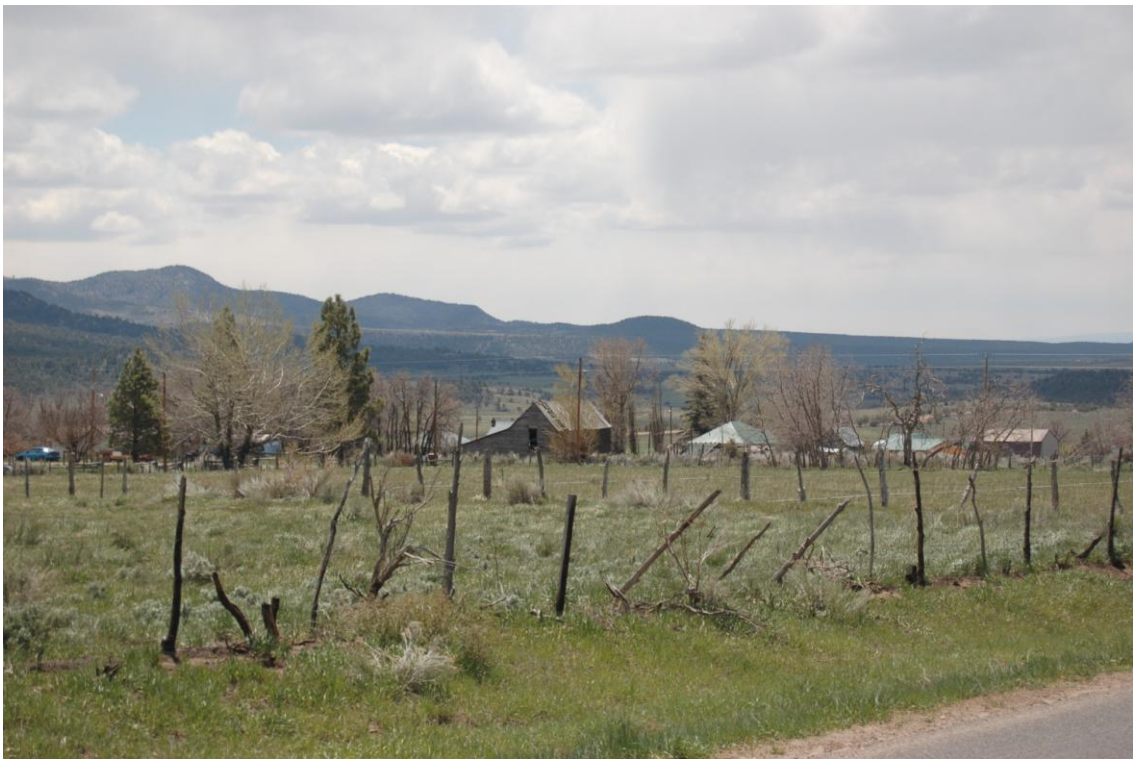
1. Project Name Alton Coal EIS	4. Location	5. Location Sketch
2. Key Observation Point #3 Town of Alton, North end of main street, looking south	UTM - 12 S 0368843 4145062	See attached photo
3. VRM Class IV

1. LAND/WATER		2. VEGETATION	3. STRUCTURES
FORM	Large, open, natural landscape. Gently rolling hills throughout north south trending valley. Sheer sandstone cliff face visible to the east. Somewhat jagged low rising mountain ranges in the BG.	Distinct stands of rounded juniper interspersed with taller pinyon and low rounded sagebrush and grasses in MG and BG. Tall conical fir trees on mountains to the west.	Bucolic setting. Rectangular geometric structures in town of Alton. Mix of new and old homes.
LINE	Hills throughout valley form gentle undulating, sweeping horizontal lines.	Long sweeping line of trees following lines of hills. Diffuse edge of stands of juniper along hills and diagonal to surrounding mountains.	Tall complex trees surrounding homes. Long angular lines of juniper post barbed wire fences. Banded line of road through town. Geometrical lines of agricultural fields in FG.
COLOR	Area is currently covered in vegetation. Some dull grays and tans visible on mountains in the BG where dirt roadways cross terrain.	Multiple shades of green – dull light gray/greens of shrubs and grasses to darker greens of junipers.	Reflective black asphalt road through center of town. Reflective metal roofs. Buildings and homes are metal, white, tan and earth tones. Vibrant bright green fields in FG.

TEX- TURE	Mountains in BG medium to coarse.	Dense stands of juniper and sage. Medium stands of fir.	Structures are smooth in BG, rougher in the FG. Smooth road, rooftops in FG.

1. LAND/WATER		2. VEGETATION	3. STRUCTURES
FORM	Most of disturbance would be in MG. Large horizontal edge of high wall and pit disturbance (removal of up to 300 feet of overburden, up to 600 foot high wall) interspersed with rolling hills. Temporary tall, conical stockpiles of topsoil. Temporary tall, conical stockpiles of coal. Underground mining is proposed for FG.	Patchy stands of vegetation interspersed with pit and road disturbance.	Portable and fixed location 30 foot tall vertical light towers. Geometric Diesel power generators.
LINE	Multiple sharp, geometric lines	Sharp butt edge between vegetation and pit disturbance.	Simple sharp vertical lines, geometric, rectangular generators.
COLOR	Grays, tans, and reddish browns of exposed soils and rocks of pit and new mine roads. Darker grays, blacks of stockpiled coal.	None	Reflective metal light towers, dull metallic generators. Reddish tan service roads.

SECTION D. CONTRAST RATING <u>X</u> SHORT TERM LONG TERM																	
1. DEGREE OF CONTRAST		FEATURES										2. Does project design meet visual resource management objectives? <u>X</u> Yes No (Explain on reverse side)					
		LAND/WATER BODY (1)				VE GETATION (2)				STRUCTURES (3)				3. Additional mitigating measures recommended? Yes X_ No (Explain on reverse side)			
		Strong	Moderate	Weak	None	Strong	Moderate	Weak	None	Strong	Moderate	Weak	None	Evaluators Name(s) _____ Date _____			
														Steve Leslie _____ 5.13.2008 SWCA Environmental Consultants			
ELEMENT	Form	X					X					X					
	Line	X					X					X					
	Color		X					X				X					
	Texture		X					X				X

Looking southeast from north end of Alton.

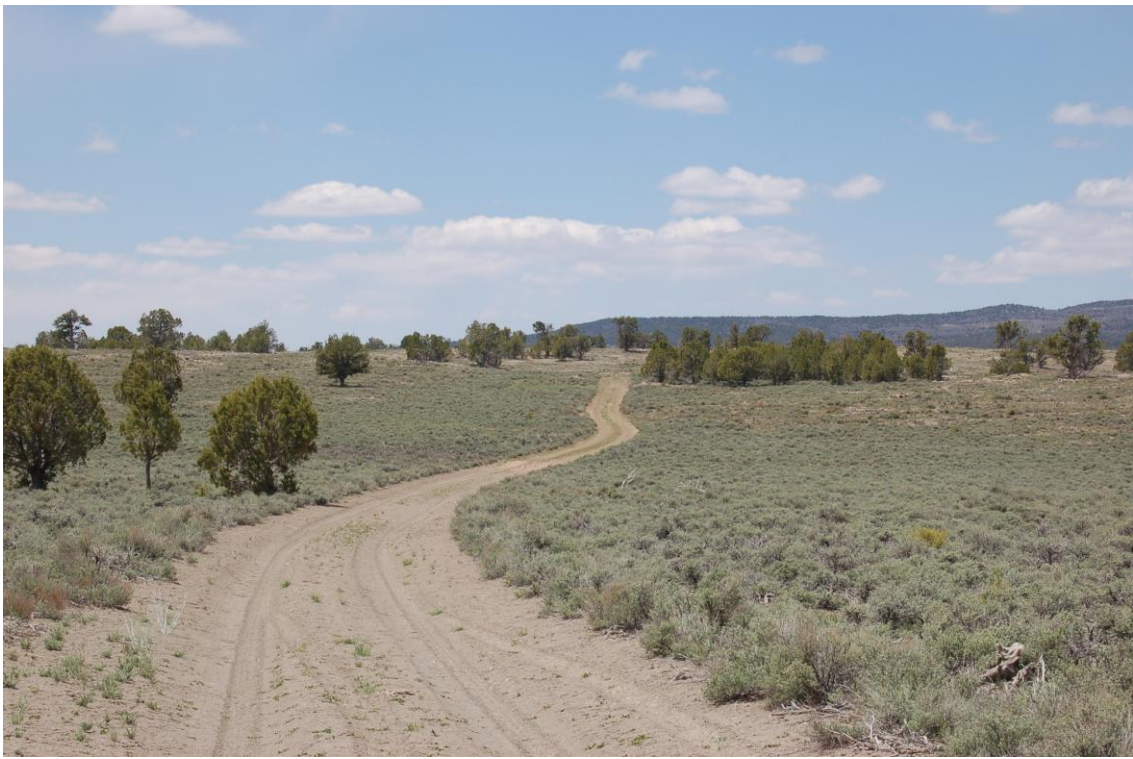
1. Project Name Alton Coal EIS		4. Location		5. Location Sketch
2. Key Observation Point #4 From KFO Route 116, looking west and north		UTM - 12 S 0371206 4138776

3. VRM Class IV				
SECTION B. CHARACTERISTIC LANDSCAPE DESCRIPTION				
1. LAND/WATER		2. VEGETATION		3. STRUCTURES
FORM	Large, open, natural landscape. Broad, gently rolling hills throughout north south trending valley. Somewhat rugged low rising mountain ranges to the west in the BG.	Patchy stands of juniper interspersed with single trees and low rounded sagebrush and grasses in MG and BG.		Dirt roads cut a narrow band across rolling hills.
LINE	Undulating, sweeping horizontal lines.	Long sweeping line of trees following lines of hills. Diffuse edge of stands of juniper along hills and diagonal to surrounding mountains.		Medium sweeping line of two track dirt road. Horizontal and Vertical lines of wood and wire strand fences.
COLOR	Much of the area is covered in vegetation. Some bright reds and tans are apparent on mountains in the BG	Multiple shades of green – dull light gray/greens of shrubs and grasses to darker greens of junipers.		Tannish gray two track dirt roads – brown and rust colored fence lines.

TEX- TURE	Mountains in BG medium to coarse.	Medium coarse stands of juniper. Dense sagebrush		Structures are smooth in BG, rougher in the FG. Smooth two track roads.
SECTION C. PROPOSED ACTIVITY DESCRIPTION

1. LAND/WATER		2. VEGETATION		3. STRUCTURES
FORM	Most of disturbance would be in MG. Large horizontal edge of high wall and pit disturbance (removal of up to 300 feet of overburden, up to 600 foot high wall) interspersed with rolling hills. Temporary tall, conical stockpiles of topsoil. Temporary tall, conical stockpiles of coal. Underground mining is proposed for FG.	Patchy stands of vegetation interspersed with pit and road disturbance.		Portable and fixed location 30 foot tall vertical light towers. Geometric Diesel power generators.
LINE	Multiple sharp, geometric lines	Sharp butt edge between vegetation and pit disturbance.		Simple sharp vertical lines, geometric, rectangular generators.
COLOR	Grays, tans, and reddish browns of exposed soils and rocks of pit and new mine roads. Darker grays, blacks of stockpiled coal.	None		Reflective metal light towers, dull metallic generators. Reddish tan service roads.

From KFO Route 116, looking west and north.

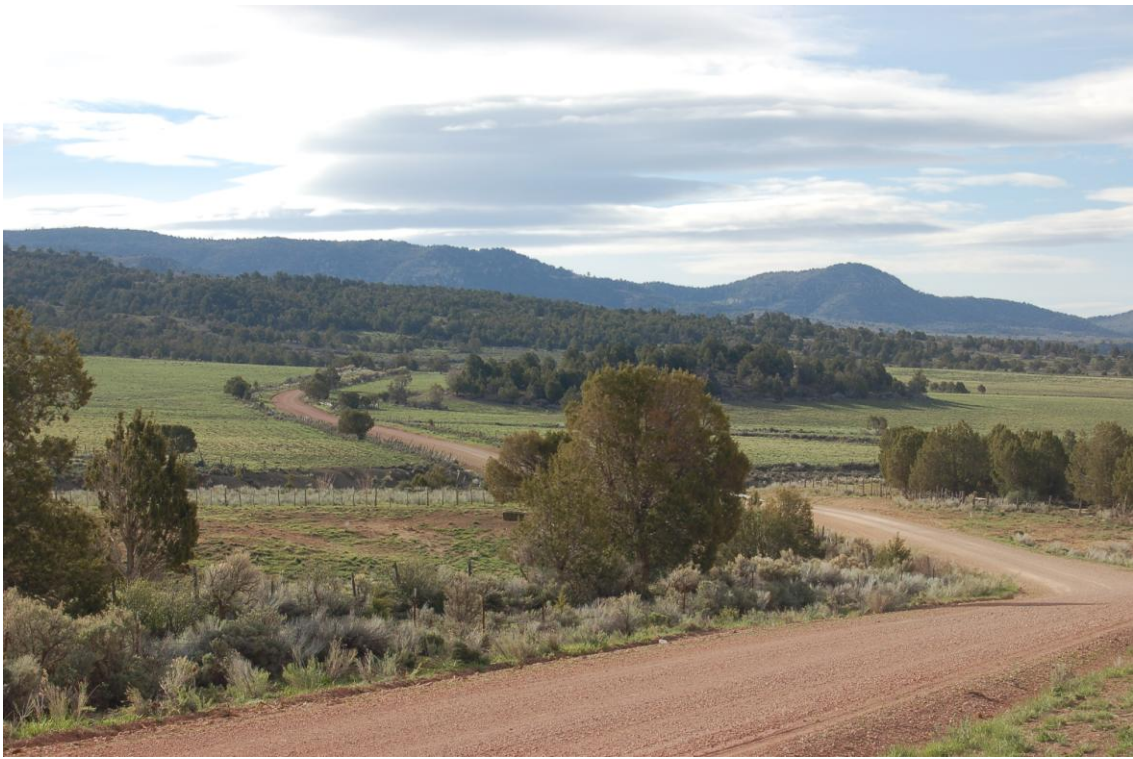
1. Project Name Alton Coal EIS		4. Location UTM - 12 S 0369897 4142626 Elevation 6,877'	5. Location Sketch See attached photo
2. Key Observation Point #5 From KFO Route 116, looking west and north

3. VRM Class IV			
SECTION B. CHARACTERISTIC LANDSCAPE DESCRIPTION			
1. LAND/WATER		2. VEGETATION	3. STRUCTURES
FORM	Large, open, natural landscape. Broad, gently rolling hills throughout north south trending valley. Somewhat rugged low rising mountain ranges to the west in the BG.	Patchy stands of juniper interspersed with single trees and low rounded sagebrush and grasses in MG and BG.	Dirt roads cut a narrow band across rolling hills.
LINE	Undulating, sweeping horizontal lines.	Long sweeping line of trees following lines of hills. Diffuse edge of stands of juniper along hills and diagonal to surrounding mountains.	Medium sweeping line of two track dirt road. Horizontal and Vertical lines of wood and wire strand fences.
COLOR	Much of the area is covered in vegetation. Some bright reds and tans are apparent on mountains in the BG	Multiple shades of green – dull light gray/greens of shrubs and grasses to darker greens of junipers.	Tannish gray two track dirt roads – brown and rust colored fence lines.

TEX- TURE	Mountains in BG medium to coarse.	Medium coarse stands of juniper. Dense sagebrush	Structures are smooth in BG, rougher in the FG. Smooth two track roads.
SECTION C. PROPOSED ACTIVITY DESCRIPTION

1. LAND/WATER		2. VEGETATION	3. STRUCTURES
FORM	Most of disturbance would be in MG. Large horizontal edge of high wall and pit disturbance (removal of up to 300 feet of overburden, up to 600 foot high wall) interspersed with rolling hills. Temporary tall, conical stockpiles of topsoil. Temporary tall, conical stockpiles of coal. Underground mining is proposed for FG.	Patchy stands of vegetation interspersed with pit and road disturbance.	Portable and fixed location 30 foot tall vertical light towers. Geometric Diesel power generators. Sharp geometric lines of operations and maintenance facilities.
LINE	Multiple sharp, geometric lines	Sharp butt edge between vegetation and pit disturbance.	Simple sharp vertical lines, geometric, rectangular generators. Square, cleared areas for equipment parking and storage.
COLOR	Grays, tans, and reddish browns of exposed soils and rocks of pit and new mine roads. Darker grays, blacks of stockpiled coal.	None	Reflective metal light towers, dull metallic generators and buildings. Reddish tan service roads.

Looking northwest from KFO Route 116 within the tract.

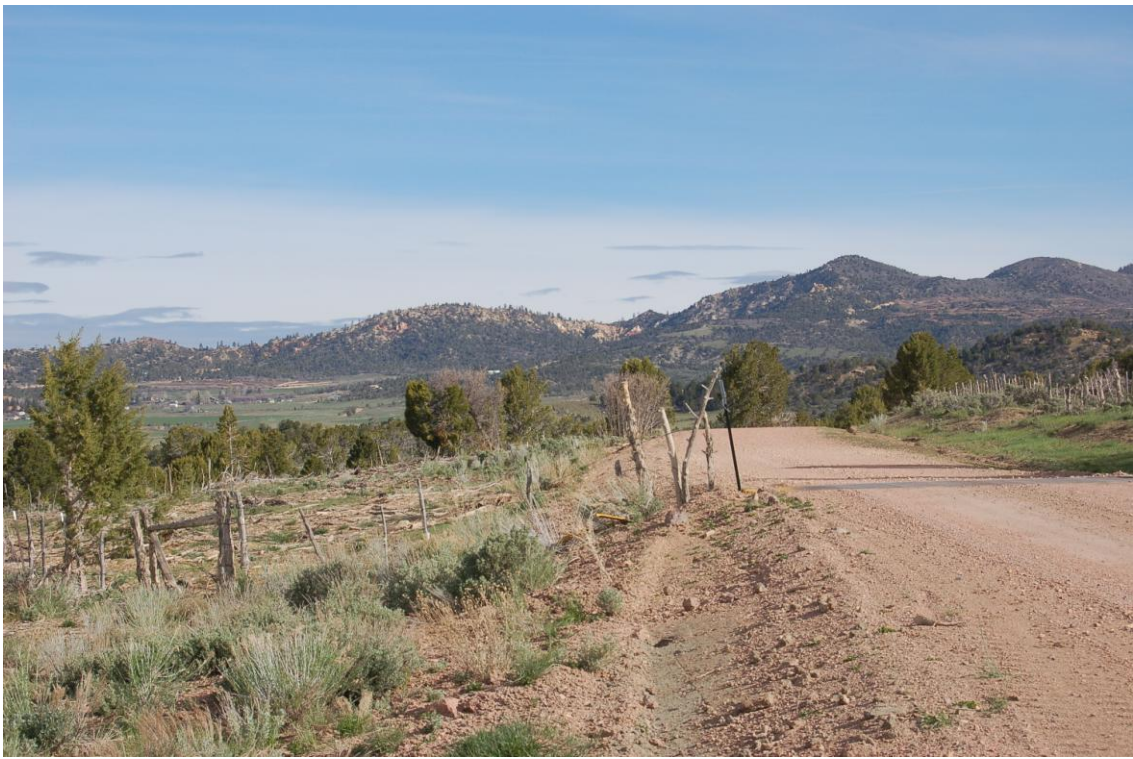
1. Project Name Alton Coal EIS	4. Location	5. Location Sketch
2. Key Observation Point #6 From KFO Route 116 at cattle guard, looking northeast, north, and north west	UTM - 12 S 0370961 4141190 Elevation 6,946'	See attached photo
3. VRM Class IV

1. LAND/WATER		2. VEGETATION	3. STRUCTURES
FORM	Large, open, natural landscape. Broad, gently rolling hills throughout north south trending valley. Somewhat rugged low rising mountain ranges to the west in the BG.	Patchy stands of juniper interspersed with single trees and low rounded sagebrush and grasses in MG and BG.	Dirt roads cut a narrow band across rolling hills.
LINE	Undulating, sweeping horizontal lines.	Long sweeping line of trees following lines of hills. Diffuse edge of stands of juniper along hills and diagonal to surrounding mountains.	Medium sweeping line of two track dirt road. Horizontal and Vertical lines of wood and wire strand fences.
COLOR	Much of the area is covered in vegetation. Some bright reds and tans are apparent on mountains in the BG	Multiple shades of green – dull light gray/greens of shrubs and grasses to darker greens of junipers.	Tannish gray two track dirt roads – brown and rust colored fence lines.

TEXTURE	Mountains in BG medium to coarse.	Medium coarse stands of juniper. Dense sagebrush	Structures are smooth in BG, rougher in the FG. Smooth two track roads.

1. LAND/WATER		2. VEGETATION	3. STRUCTURES
FORM	Most of disturbance would be in MG. Large horizontal edge of high wall and pit disturbance (removal of up to 300 feet of overburden, up to 600 foot high wall) interspersed with rolling hills. Temporary tall, conical stockpiles of topsoil. Temporary tall, conical stockpiles of coal. Underground mining is proposed for FG.	Patchy stands of vegetation interspersed with pit and road disturbance.	Portable and fixed location 30 foot tall vertical light towers. Geometric Diesel power generators.
LINE	Multiple sharp, geometric lines	Sharp butt edge between vegetation and pit disturbance.	Simple sharp vertical lines, geometric, rectangular generators.
COLOR	Grays, tans, and reddish browns of exposed soils and rocks of pit and new mine roads. Darker grays, blacks of stockpiled coal.	None	Reflective metal light towers, dull metallic generators. Reddish tan service roads.

TEX- TURE	Smooth				None				Smooth					
	SECTION D. CONTRAST RATING <u> X </u> SHORT TERM <u> </u> LONG TERM <u> </u>													
	1. DEGREE OF CONTRAST	FEATURES												2. Does project design meet visual resource management objectives? <u> X </u> Yes <u> </u> No (Explain on reverse side)
		LAND/WATER BODY (1)				VE GETATION (2)				STRUCTURES (3)				3. Additional mitigating measures recommended? <u> </u> Yes <u> X </u> No (Explain on reverse side)
Strong		Moderate	Weak	None	Strong	Moderate	Weak	None	Strong	Moderate	Weak	None	Evaluators Name(s) Date	
ELEMENT	Form	X				X				X				Steve Leslie 5.13.2008 SWCA Environmental Consultants
	Line	X				X				X				
	Color		X					X			X			
	Texture		X					X				X

From KFO Route 116 at cattle guard, looking northeast, north, and north west.

SECTION D. (Continued)													
<p>2. VRM Class IV allows major modifications to the characteristic landscape to occur.</p>													
<p>3. The mitigation measures included in the proposed action and alternative call for complete site reclamation including re-contouring pit disturbances, facilities, and dispersed facilities would restore the characteristic landscape to a more natural condition upon completion of mining activities.</p>													
<p>U S GOVERNMENT PRINTING OFFICE: 1985-461-988/33094</p>

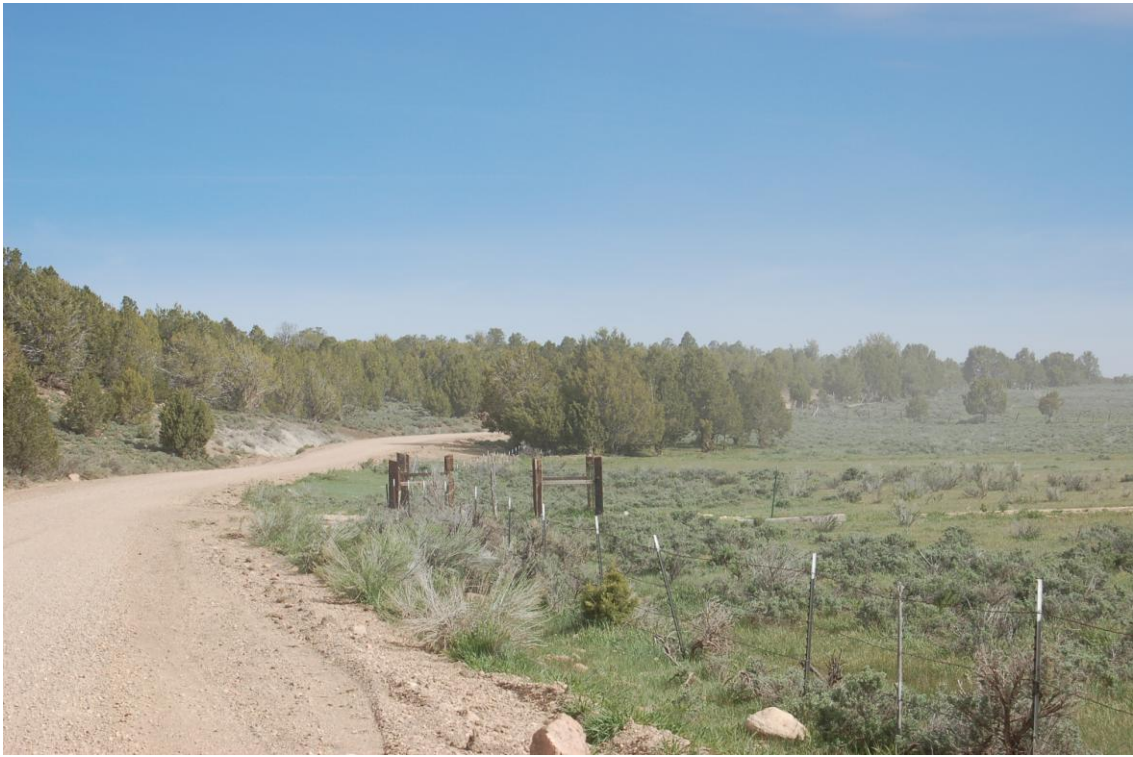
1. Project Name Alton Coal EIS		4. Location UTM - 12 S 0371658 4137465	5. Location Sketch See attached photo	
2. Key Observation Point #7 From KFO Route 116 at the south end of the tract looking north.

3. VRM Class IV				
SECTION B. CHARACTERISTIC LANDSCAPE DESCRIPTION				
1. LAND/WATER		2. VEGETATION		3. STRUCTURES
FORM	Large, open, natural landscape. Broad, gently rolling hills throughout north south trending valley. Somewhat rugged low rising mountain ranges to the west in the BG.	Thick, dense stands of conical shaped junipers. Wide open valley extending to the north full of low grasses mixed with rounded sagebrush.		Dirt road cut a wide band along dense trees through FG. Short vertical fence lines cutting across open valley.
LINE	Undulating, sweeping horizontal lines. Alluvial fans sweep down from mountains at an angle to the valley floor.	Long sweeping line of trees following lines of KFO Route 116. Diffuse edge of stands of juniper sweeping down hills diagonal to mountains in the west.		Medium sweeping line of two track dirt road. Horizontal and Vertical lines of wood and wire strand fences. Geometric ranch structures in the MG.

COLOR	Much of the area is covered in vegetation. Some faint reds and tans are apparent on mountains in the BG	Multiple shades of green – dull light gray/greens of shrubs and grasses to darker greens of junipers.		Tannish gray graded dirt road – brown and rust colored fence lines and structures.
TEX-TURE	Mountains in BG medium to coarse.	Medium coarse stands of juniper. Dense sagebrush		Structures are smooth in BG, rougher in the FG. Smooth graded road.
SECTION C. PROPOSED ACTIVITY DESCRIPTION

1. LAND/WATER		2. VEGETATION		3. STRUCTURES
FORM	Most of disturbance would be in MG. Large horizontal edge of high wall and pit disturbance (removal of up to 300 feet of overburden, up to 600 foot high wall) interspersed with rolling hills. Temporary tall, conical stockpiles of topsoil. Temporary tall, conical stockpiles of coal.	Patchy stands of vegetation interspersed with pit and road disturbance.		Portable and fixed location 30 foot tall vertical light towers. Geometric Diesel power generators.
LINE	Multiple sharp, geometric lines	Sharp butt edge between vegetation and pit disturbance.		Simple sharp vertical lines, geometric, rectangular generators.
COLOR	Grays, tans, and reddish browns of exposed soils and rocks of pit and new mine roads. Darker grays, blacks of stockpiled coal.	None		Reflective metal light towers, dull metallic generators. Reddish tan service roads.
TEX-TURE	Smooth	None		Smooth

SECTION D. CONTRAST RATING _X_ SHORT TERM _LONG TERM														
DEGREE OF CONTRAST <div style="writing-mode: vertical-rl; transform: rotate(180deg); font-weight: bold;">ELEMENT</div>		FEATURES								2. Does project design meet visual resource management objectives? _X__ Yes __ No (Explain on reverse side)				
										3. Additional mitigating measures recommended? ___ Yes _X_ No (Explain on reverse side)				
		LAND/WATER BODY (1)				VE GETATION (2)				STRUCTURES (3)				
		Strong	Moderate	Weak	None	Strong	Moderate	Weak	None	Strong	Moderate	Weak	None	
		Evaluators Name(s) _____ Date _____ Steve Leslie _____ 5.13.2008 SWCA Environmental Consultants												
		Form	X				X				X			
		Line	X				X				X			
Color	X					X				X				
Texture	X					X				X

Looking northwest from the south end of the tract on KFO Route 116.
